BA-39 Project Goal and Objectives

To create sustainable marsh in an area that was primarily open water and remnant marsh using sediments dredged from the Mississippi River

Data analyzed for 2013 OM&M report collected between

January 2010-December 2012

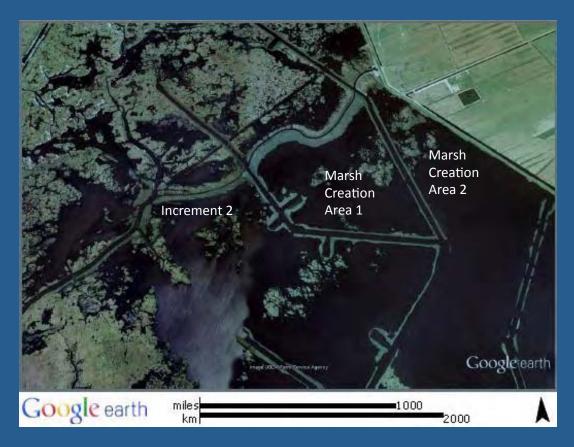
BA-39 Pre-construction Imagery

Google Earth aerial imagery of the BA-39 project area acquired pre-construction on 10/11/2007

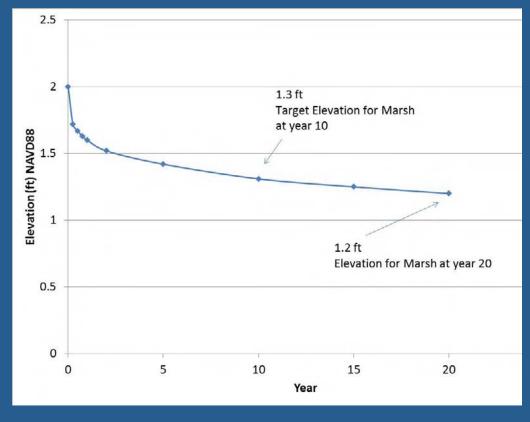
BA-39 Project Area Elevation

Target construction elevation: +2 ± 0.3 feet NAVD88

Project area target elevation: + 1.3 feet NAVD88

- * Marsh target elevation predicted to be reached at year 10 (2020)
- * Elevation was determined based on the elevation of nearby, healthy marsh
- * This elevation should provide the optimum conditions to support healthy marsh in the intertidal zone

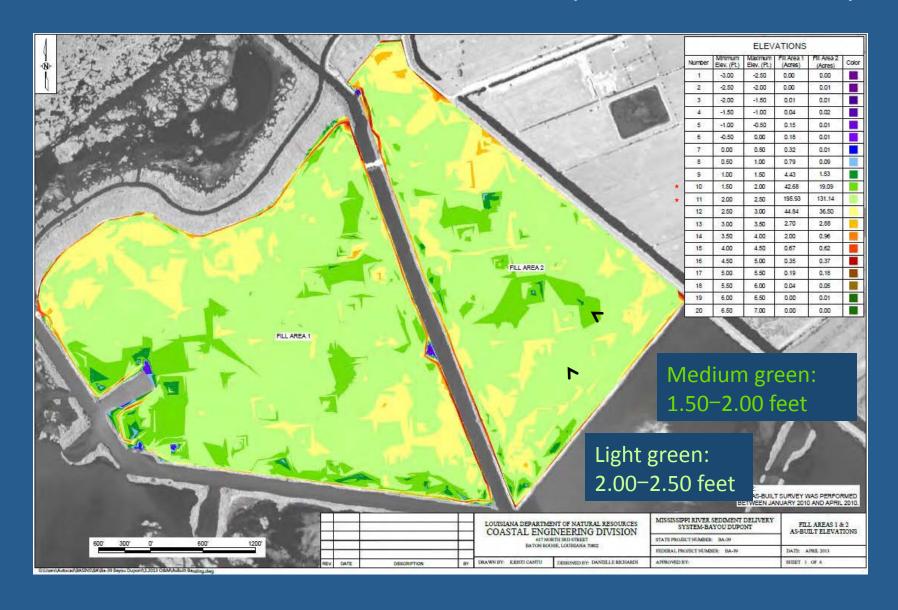
BA-39 As-Built Elevation (01/2010-04/2010)

Topographic Survey (As-Built) (01/2010–04/2010)

- Survey transects spaced 500 ft apart
- Points taken every 50 ft along transect
- Survey Results: Majority of the project area was constructed to the targeted elevation
 - * 80% (389 acres) of the project area between 1.5–2.5 feet (Fill Area 1 and Fill Area 2)
- Elevations > 3.0 ft are primarily due to surveyed containment dikes and natural ridges

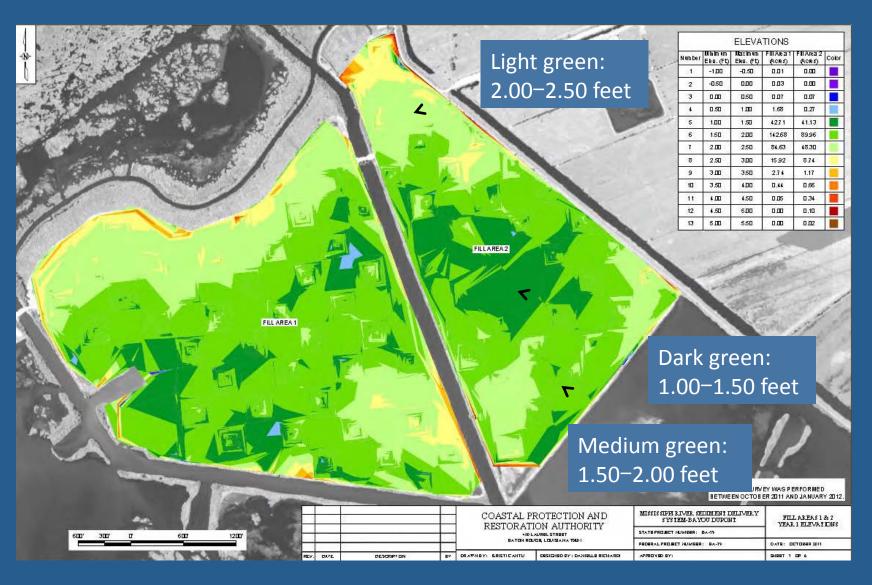
BA-39 Year 1 Elevation (10/2011-01/2012)

Topographic Survey ("Year 1") (10/2011–01/2012)

- Conducted 1.5–2.0 years after the As-Built survey
- Largest % of project area is at the predicted elevation (based on +2 ft NAVD88 construction):
 YR 1: 1.6 ft NAVD88, YR 2: 1.5 ft NAVD88
- Significant % of BA-39 is still at a higher elevation

BA-39 Elevations (10/2011-01/2012)			
Elevation Range (NAVD88)	% Fill Area 1	% Fill Area 2	% Increment 2
1.0 ft-1.5 ft	14.7	21.6	8.1
1.5 ft - 2.0 ft	49.0	47.2	50.1
2.0 ft −2.5 ft	29.1	25.3	39.8
SUM	92.8	94.1	98.0

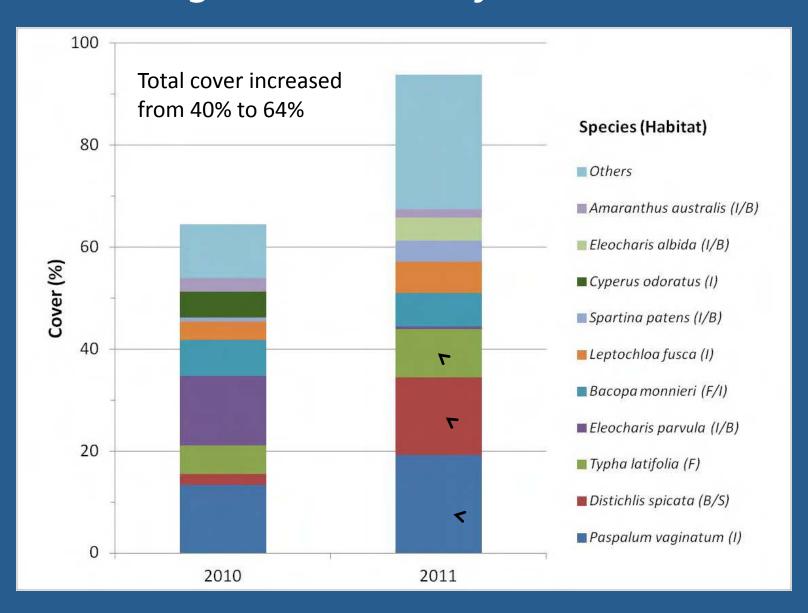
Vegetative Cover for BA-39

- Strive to encourage growth of a marsh habitat comprised of native vegetation species that are found locally in natural, healthy marsh
- Vegetation data can be an excellent assessment tool
 Will help in determination of whether land is actually
- Challenges:
 - Source of recruitment?
 - Plantings may be required
 - * 21,000 *Spartina alterniflora* (smooth cordgrass) plugs-Brazoria cultivar
 - * 5,000 *Paspalum vaginatum* (seashore paspalum) plugs-Vermilion cultivar
 - Proper elevation and tidal regime?

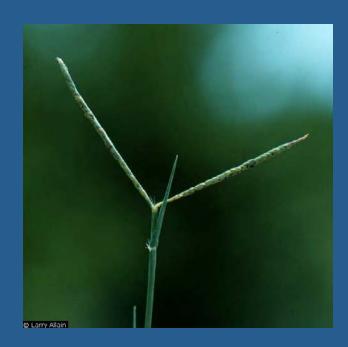
Paspalum vaginatum, Seashore paspalum

- * 5000 plugs planted (Brazoria cultivar)
- * Greatest cover averaged between years (16% cover)
- * Salt-tolerant, fast-growing species that grows well in inorganic, sandy sediments with periodic inundation. Thrives in **intermediate** marshes.

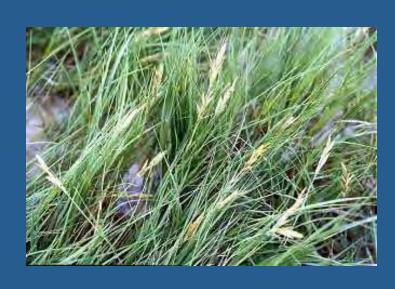
Distichlis spicatum, Saltgrass

- * 2nd most abundant plant averaged between years (9% cover)
- * Greatest increase between years (2% to 15%)
- * Brackish/saline marshes: natural component of the marsh Fresher marshes: often considered a disturbance species

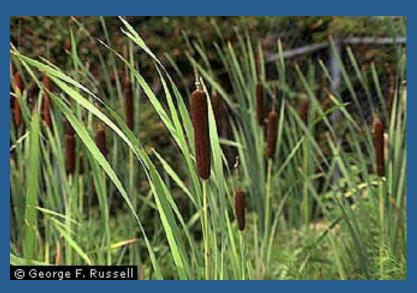
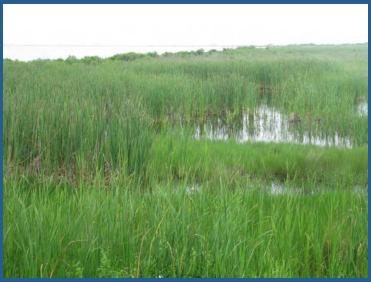
Typha latifolia, broadleaf cattail

- * 3rd most abundant species over years (8% cover)
- * Typha latifolia can grow aggressively, crowding out other species and resulting in areas of dense, monospecific stands
- * Grows well in areas that are inundated with freshwater
