ISLES DERNIERES

Trinity Island

Restoration on Trinity Island

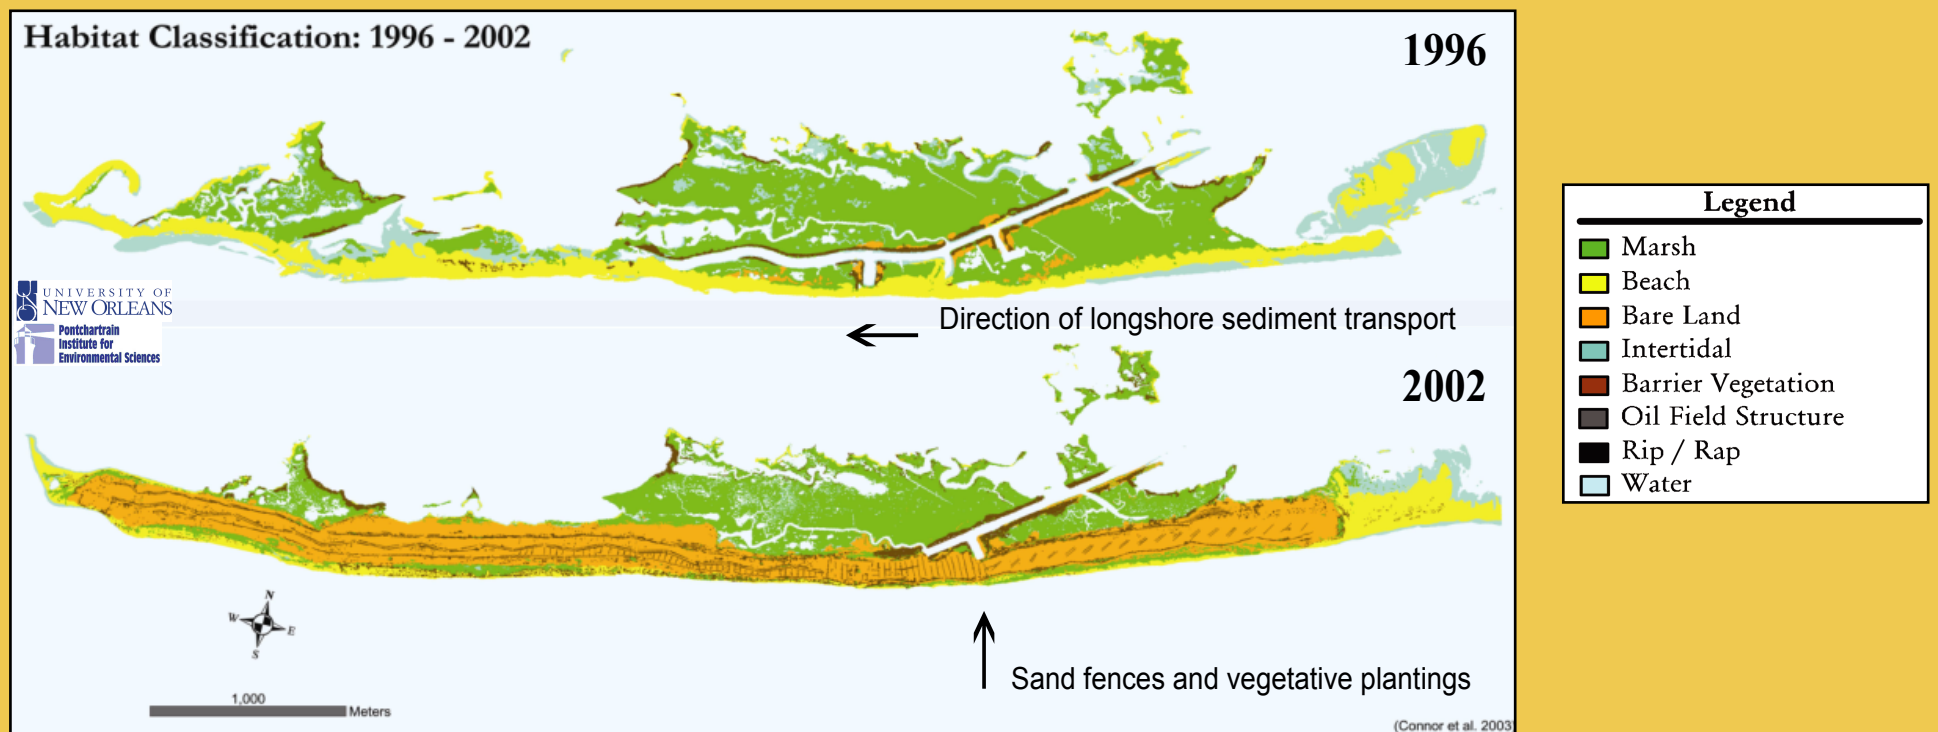
The Coastal Wetlands Planning, Protection and Restoration Act (CWPPRA) funds projects which have successfully rebuilt coastal habitats on barrier islands. These images of Trinity Island show where sediment was placed on the island to increase its height and/or width. This increases the endurance of the island during major storm events. In addition to adding sediment, sand fences were built and vegetation planted to help hold the sediment in place.

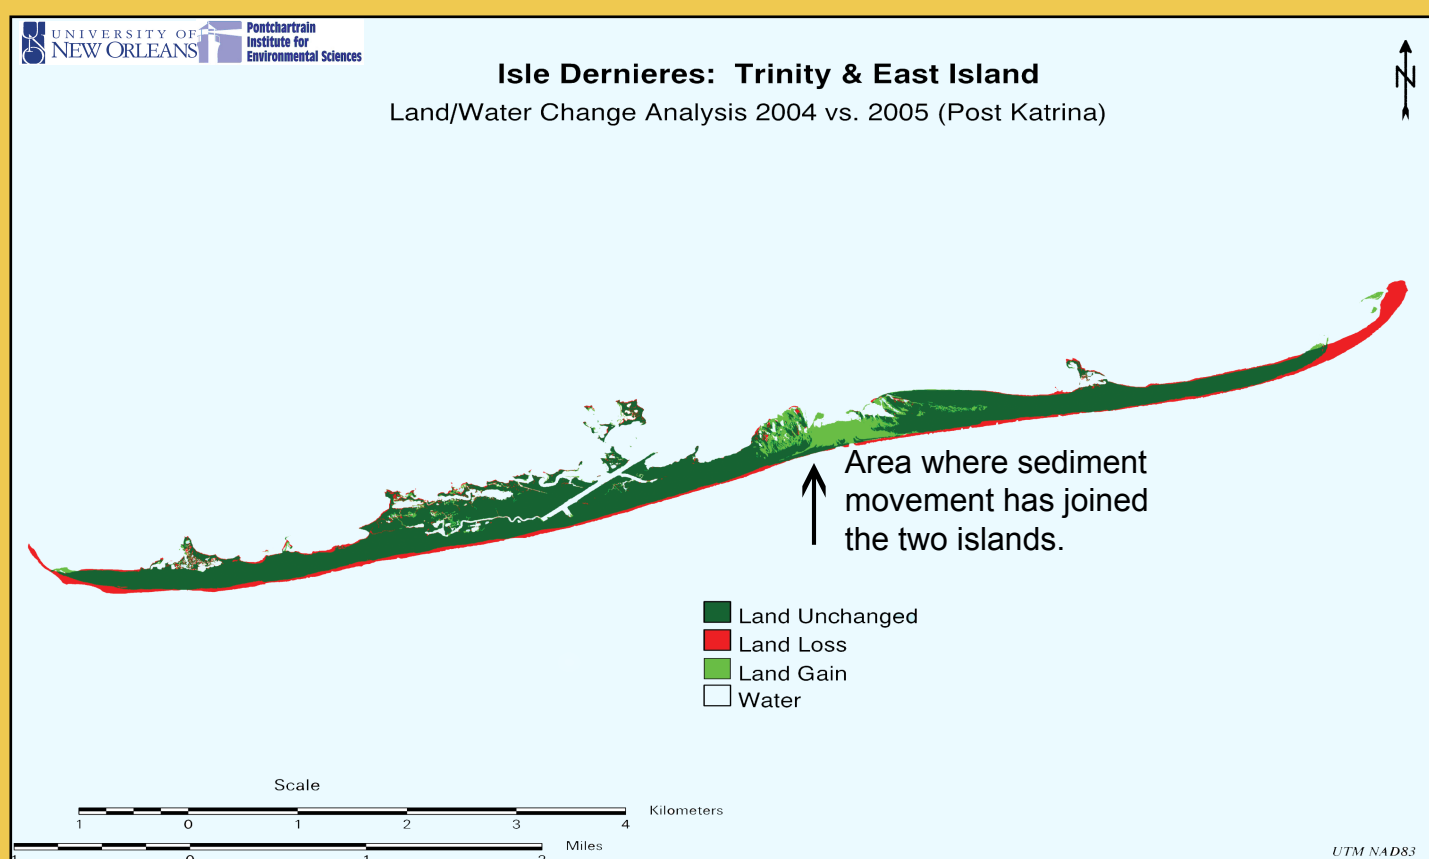
Island Changes Due to Hurricanes Katrina and Rita

This map of Trinity and East Islands highlights land change due to hurricane effects. Areas in red indicate parts of the islands where land has been lost. Sediment was redistributed by increased wave activity. Light green areas locate where sediment was redeposited, resulting in the reconnection of the two islands. The darker green areas indicate parts of the islands that remained constant despite the storms' force, although habitat was altered by the storm surge.
