ISLES DERNIERES

Whiskey Island

Restoration on Whiskey Island

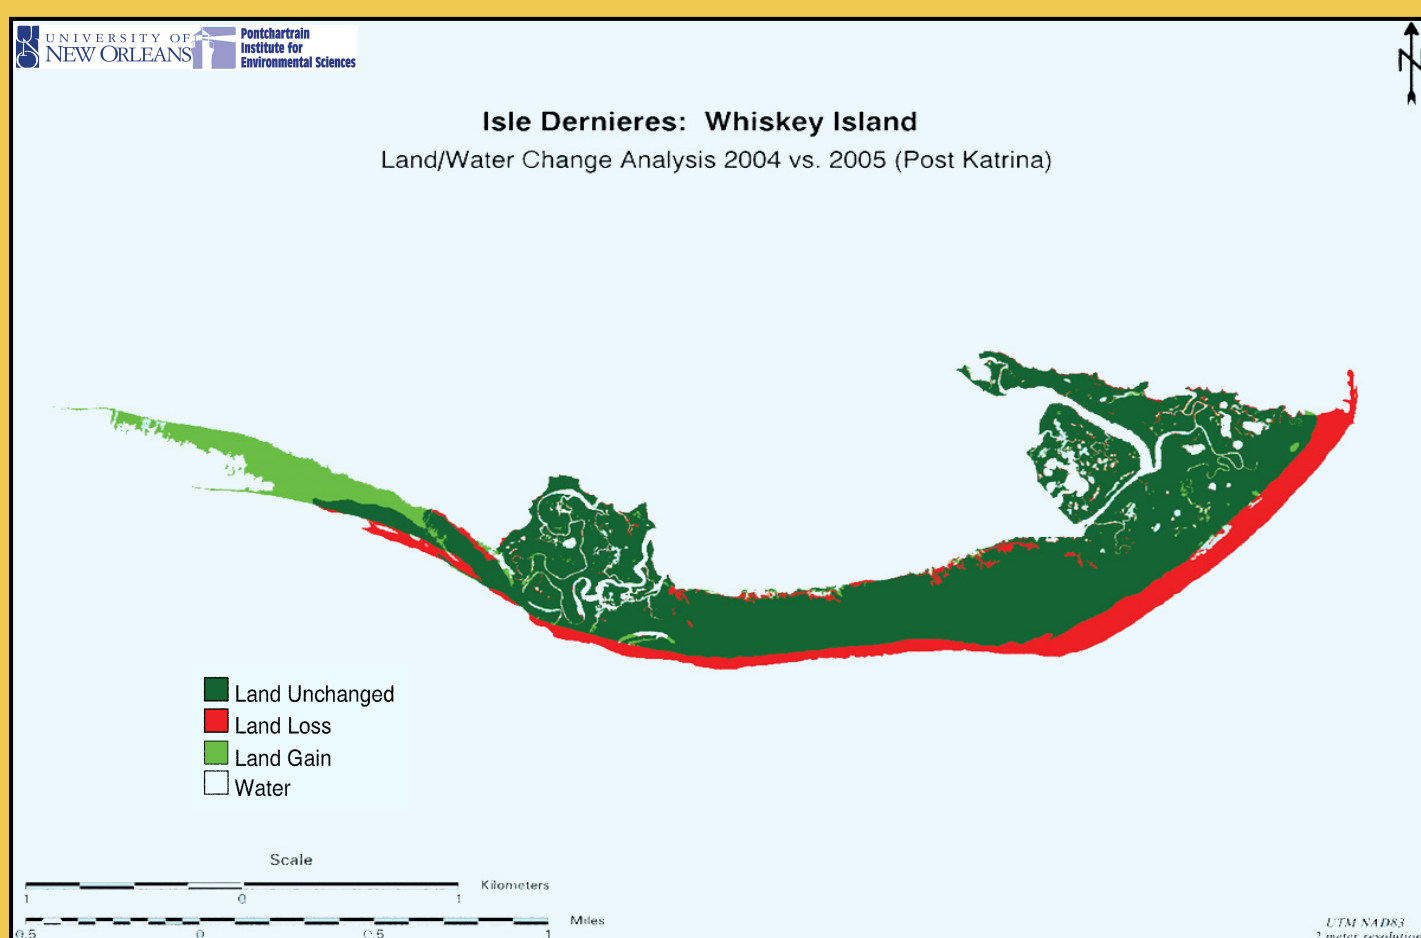
Island Changes from Hurricanes Katrina and Rita

This map of Whiskey Island highlights land change due to hurricane effects. Areas in red indicate parts of Whiskey Island where sediment has been lost. Sediment was redistributed due to increased wave activity. Light green areas locate where sediment was deposited, resulting in land gain. Dark green areas indicate areas of the island that have remained constant, despite the storms' force, although habitat was altered by the storm surge.
