Rising Above the Risk

Elevation and Reconstruction

Repetitive Loss Area Analysis & Mitigation Assessment

August 2025 – BTNEP Management Conference

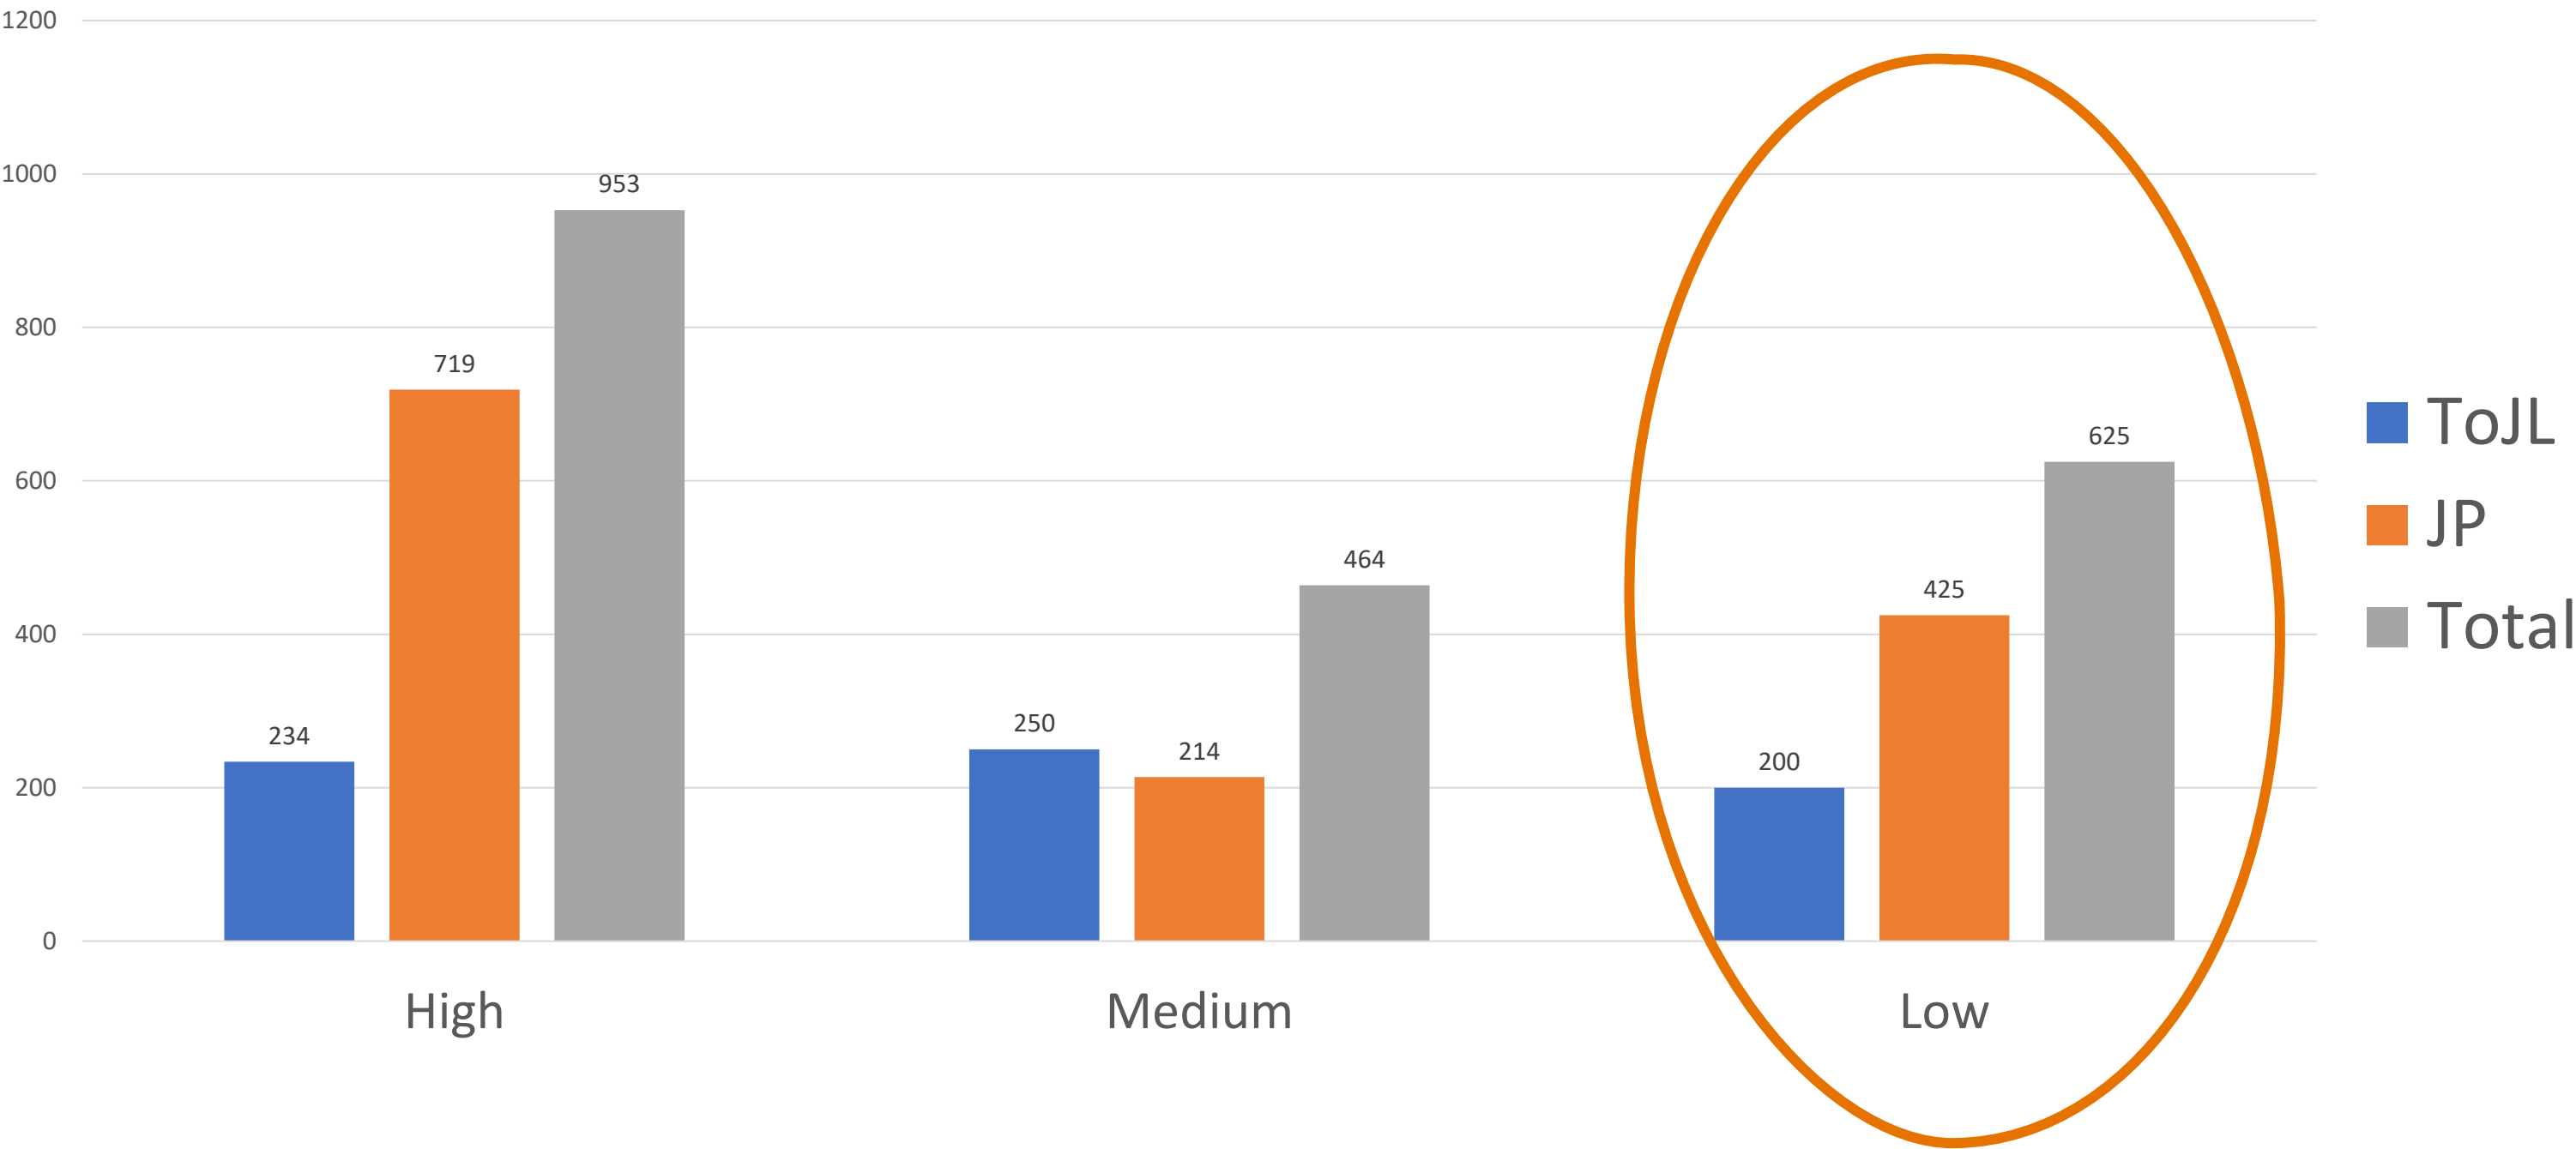
Foundation Heights

High = >5ft
Medium = 3 to 5ft
Low = < 3ft

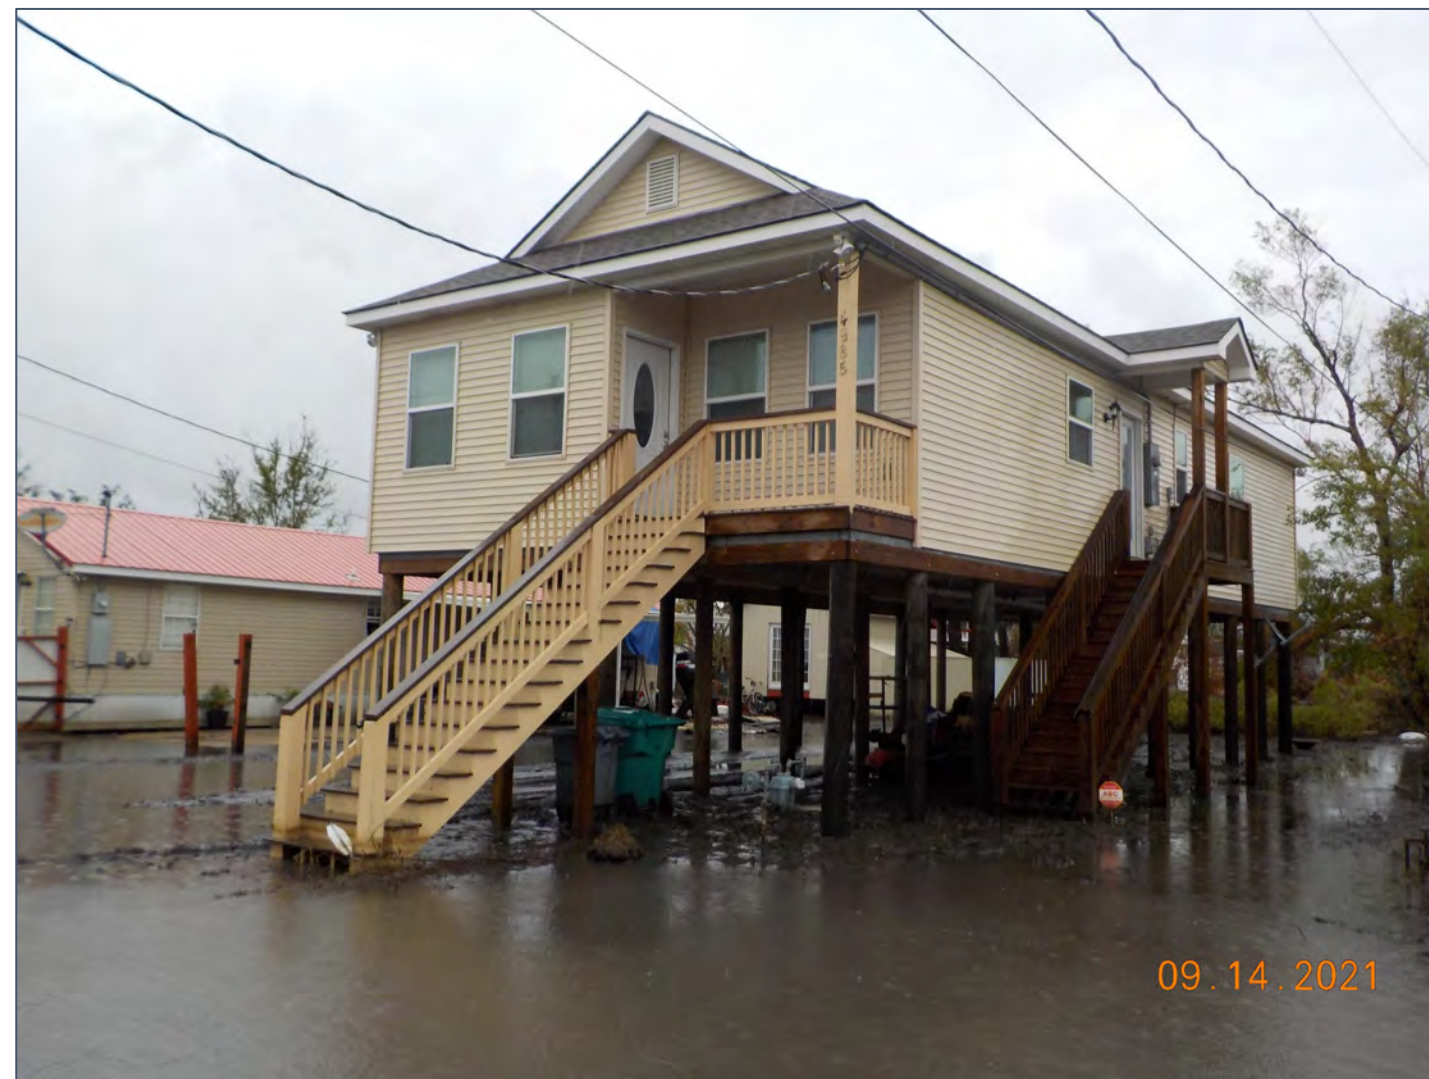
Overall Success

- None of the structures mitigated had water enter the elevated 1st floor

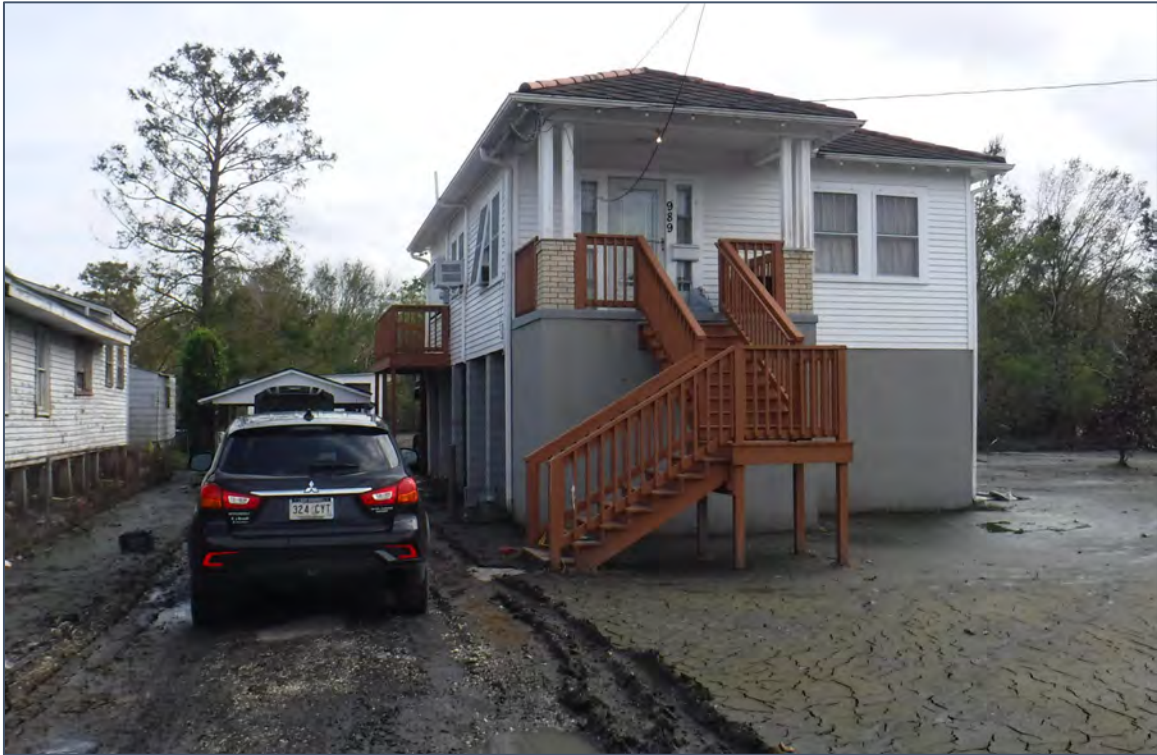
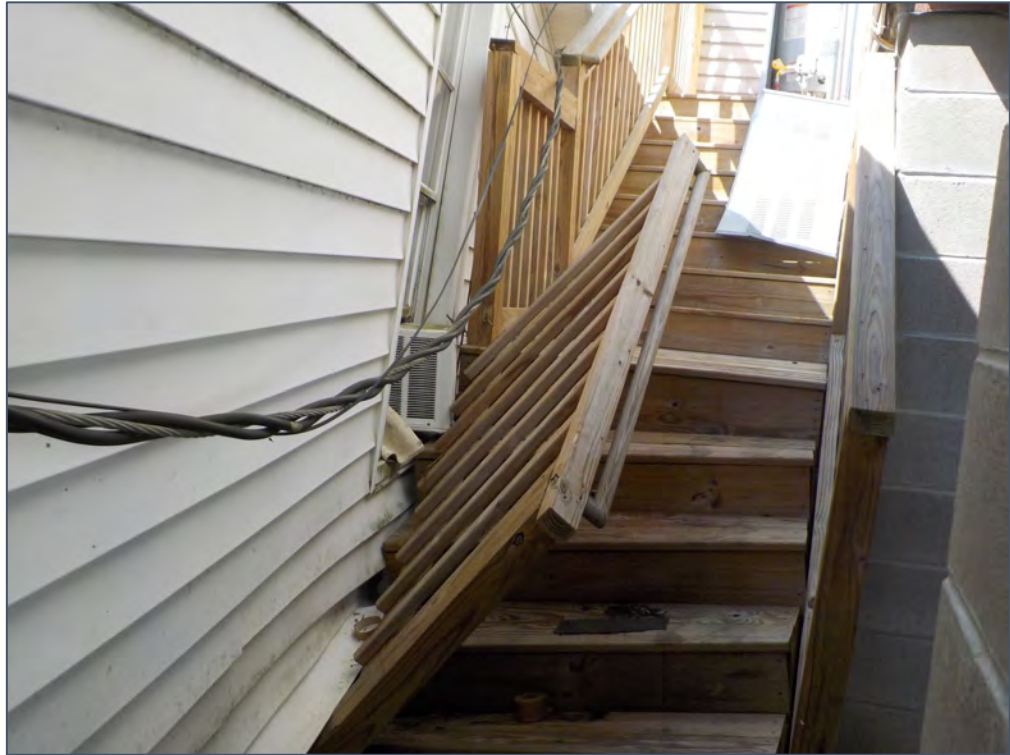
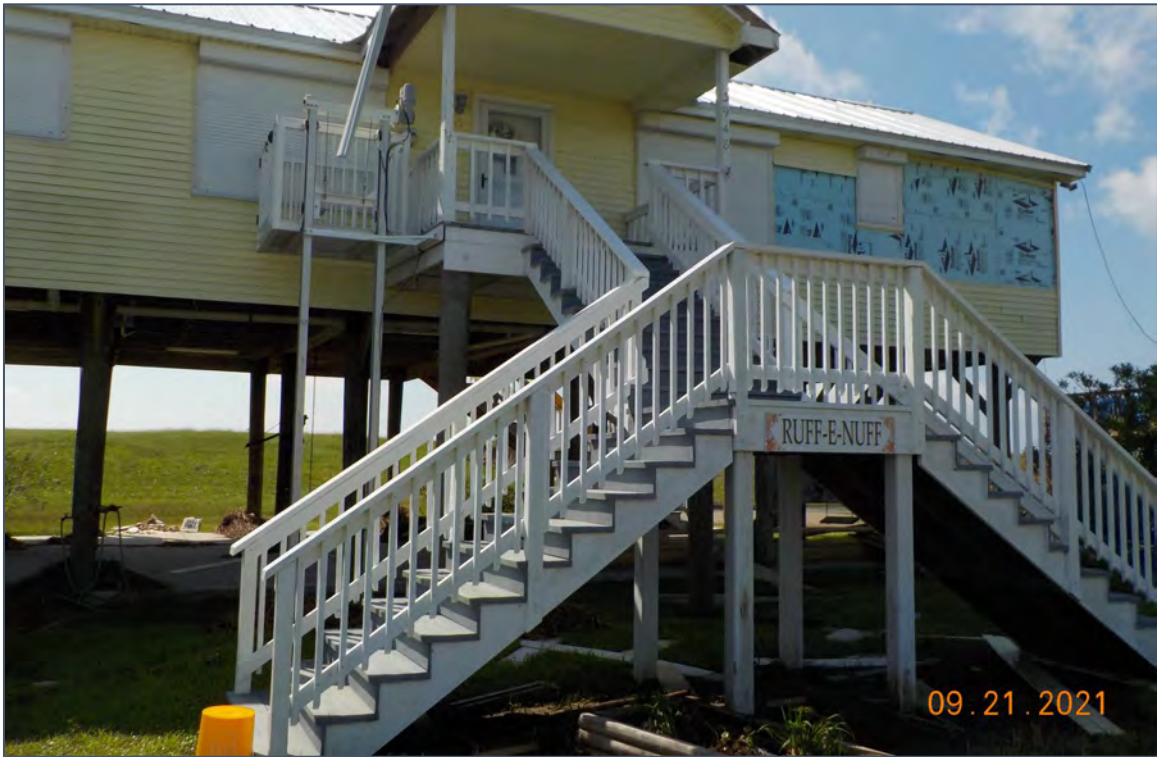
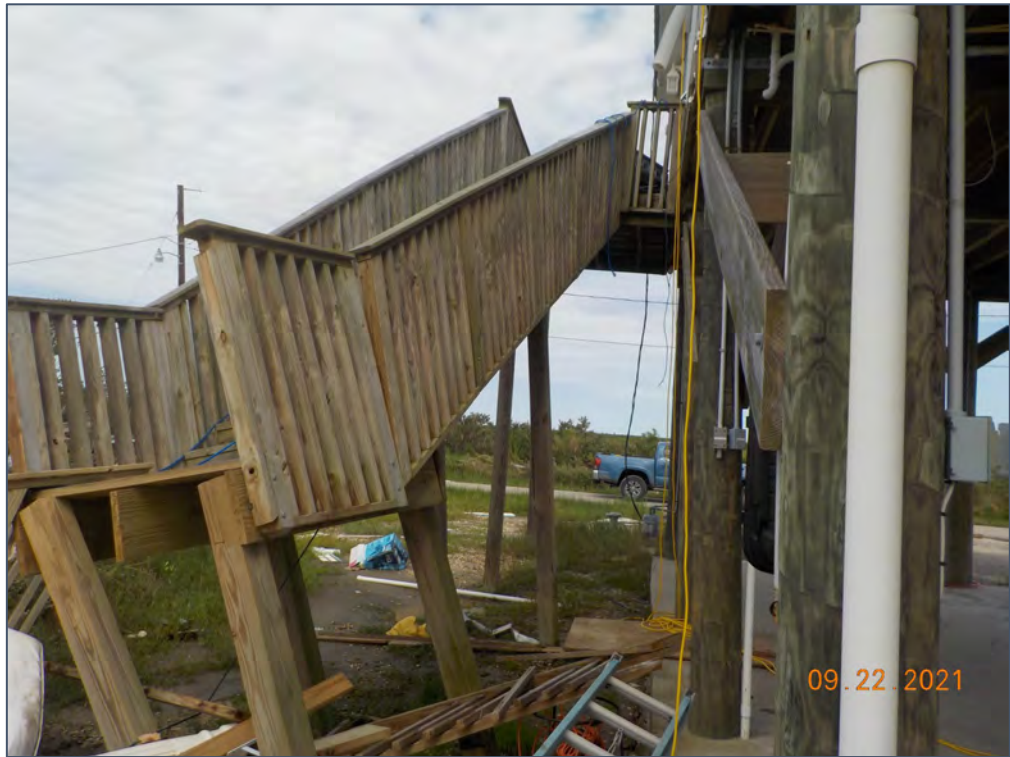
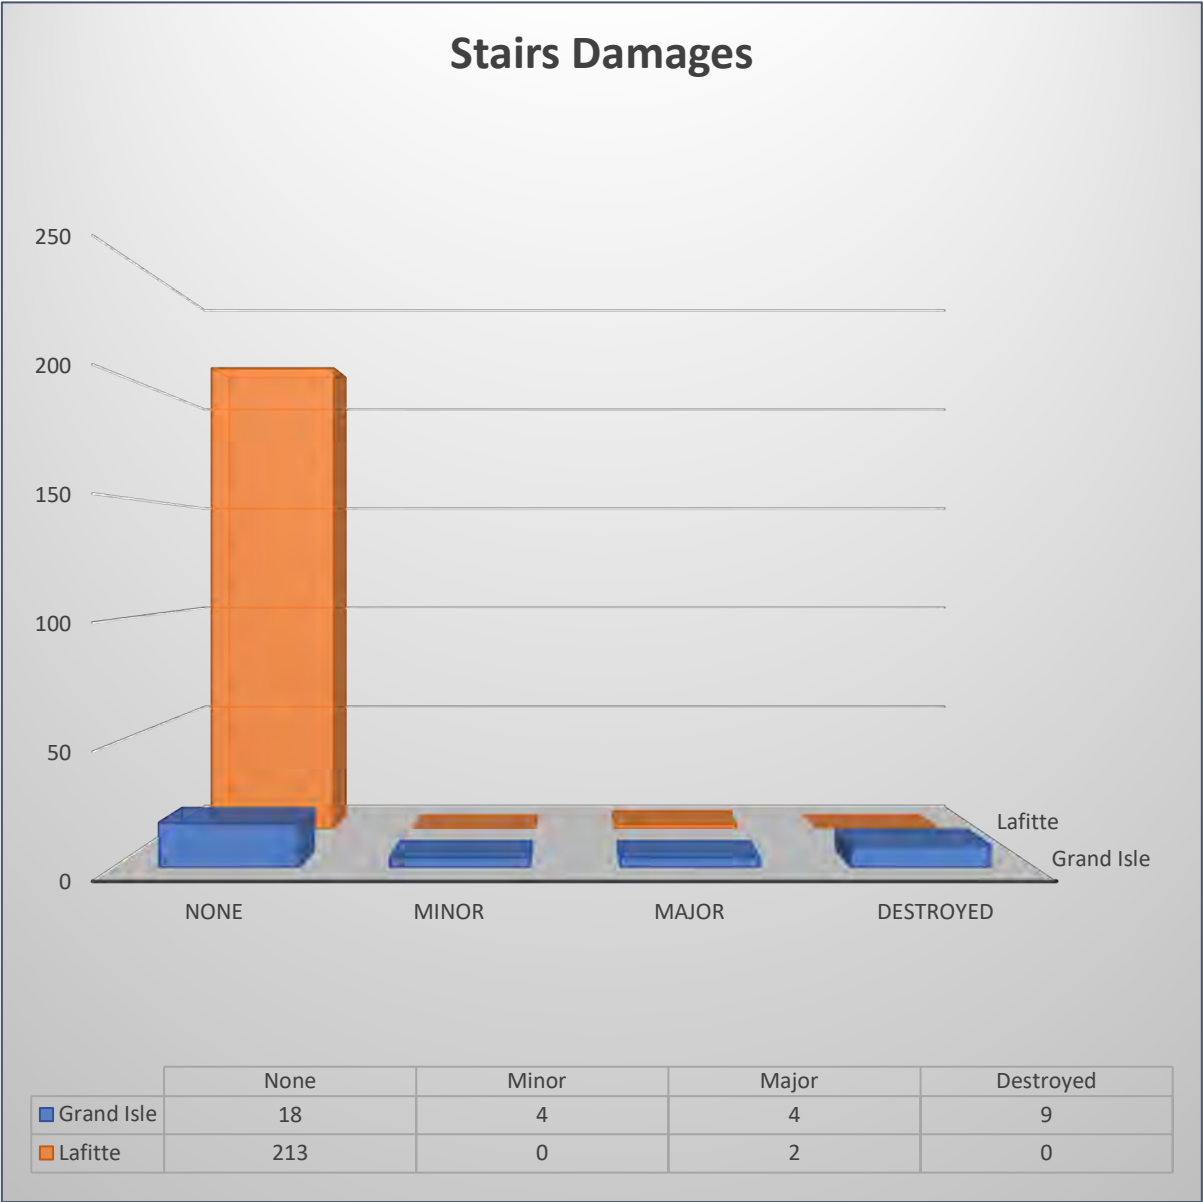
Stairs

Successes Observed

Damages Observed

- Utilities
 - Relocate gas meter if feasible
 - Water and Sewer lines next to piers if feasible
 - Electric meter above BFE
- AC
 - Secure to platform
 - Platform may need support
- Landings/Stairs/Railings
 - Use screws instead of nails
 - Reinforce existing 2nd story railings
- Awnings & Overhangs
 - Assess if it is code compliant – if not owner may need to remove before project

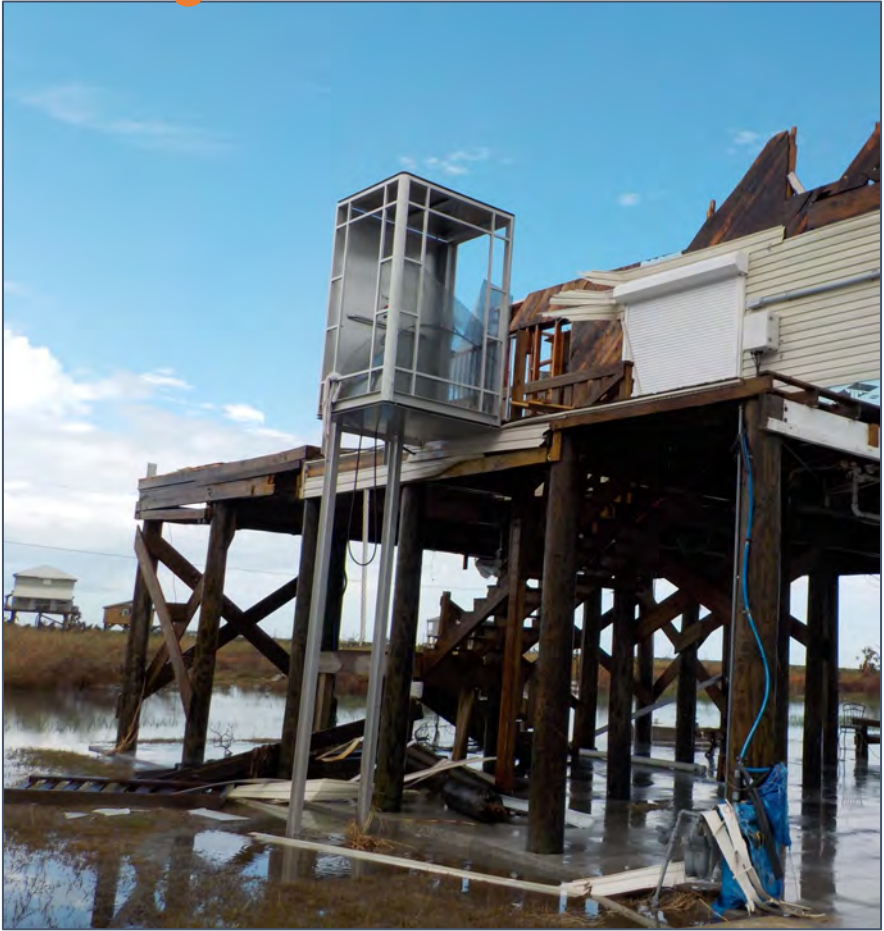
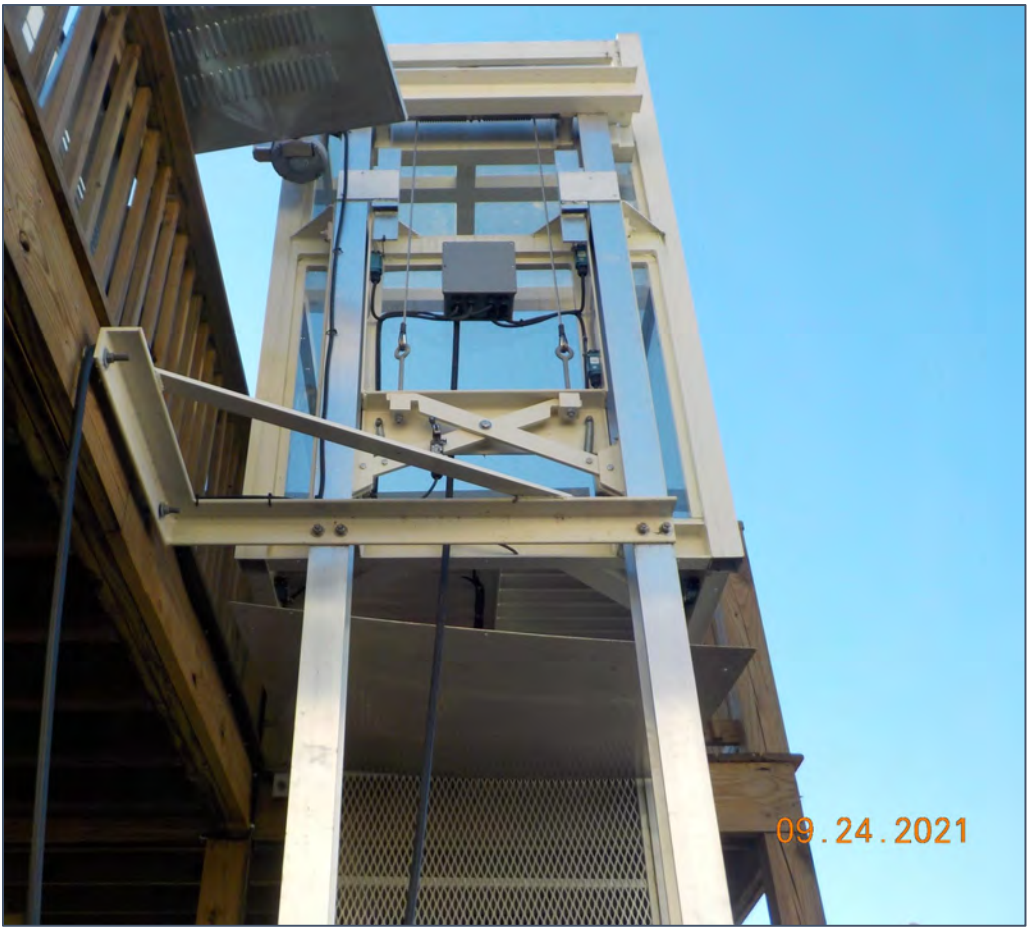
Damages Observed

ADA Ingress / Egress

- Benefits of Ramps vs Lift
- Benefits of Owner paying to install items above minimum code requirements (iron railings)
- Proper maintenance of ADA Lift & Deck/Stairs
